**BUILDING SURVEY INSPECTION REPORT ON**

**Tabor Methodist Chapel, Davies Street, Brynmawr,  
Blaenau Gwent, NP23 4AD.**

Prepared by

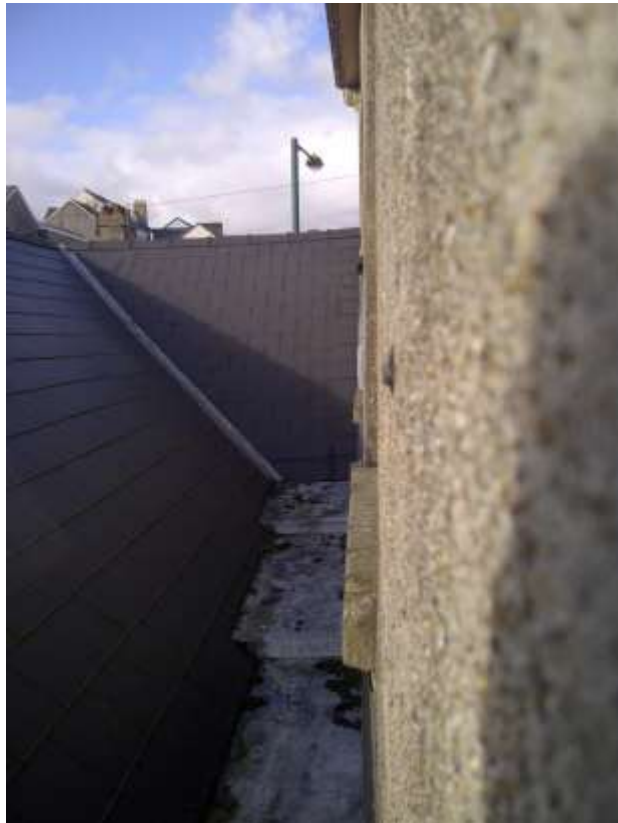
View of rear valley gutter and single storey roof finish

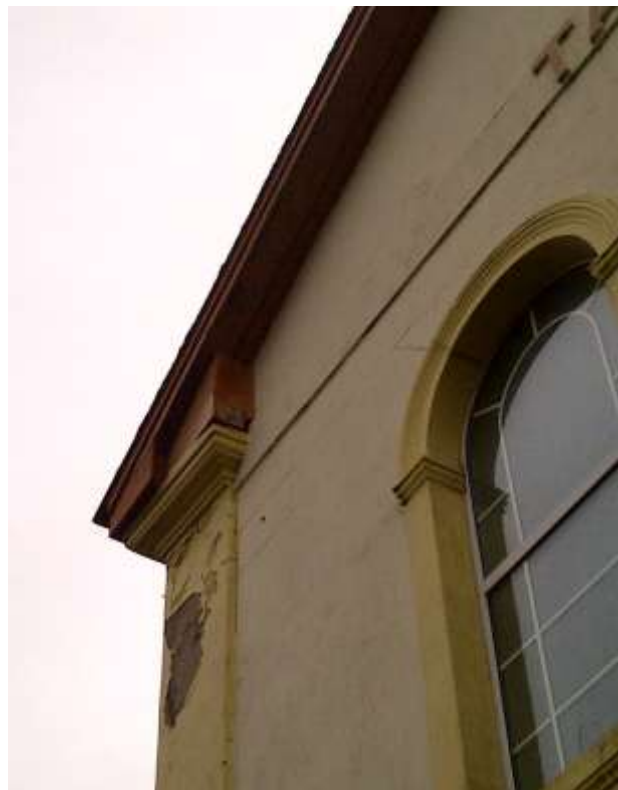
The gutters and downpipes on the main chapel are OG metal gutters with 100mm pvc downpipes. The gutters are in a poor condition with most of the joints showing signs of leaking. A section of gutter approx. one meter long is missing to the North East (front left) corner of the property and water from the roof is damaging external/internal finishes. This should be replaced as soon as possible along with the existing gutters on the main chapel.

Front wall with water damage from missing gutter section

There are numerous areas of damp to external walls which has caused damage to internal finishes and floor boarding / joists. Defective rain water goods are contributing to the damp penetration and the missing section of guttering should be replaced immediately.

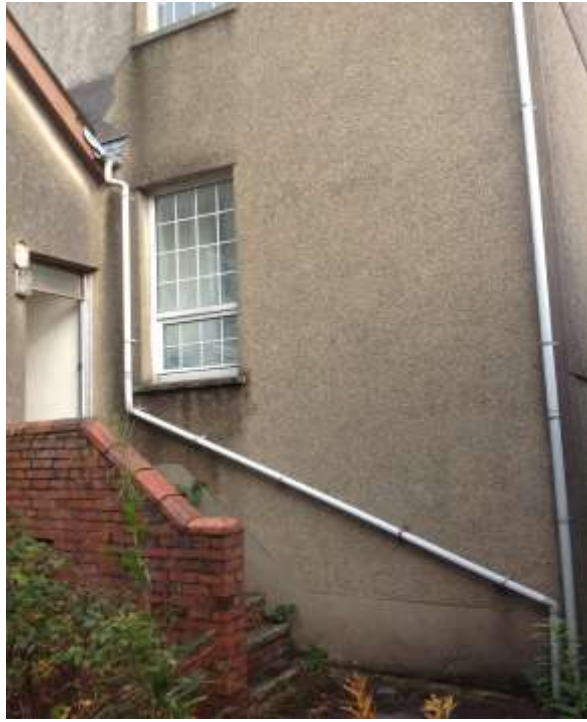
It was noted that there is no end cap to the gutter collecting the rain water from the valley gutter and one should be fitted to stop any over spilling of water. It should be noted that it is normal practice to provide a hopper head to collect rain water from valley gutters.

Missing gutter end cap and defective pointing to wall. Steps are uneven

Steps lead from the kitchen, down to the rear garden with a brick wall to the side of the steps. The steps are uneven and steep and we would advise these be re-laid to avoid the risk of tripping. The pointing to the brick side wall is in poor condition and the joints need raking out and the re-pointing.

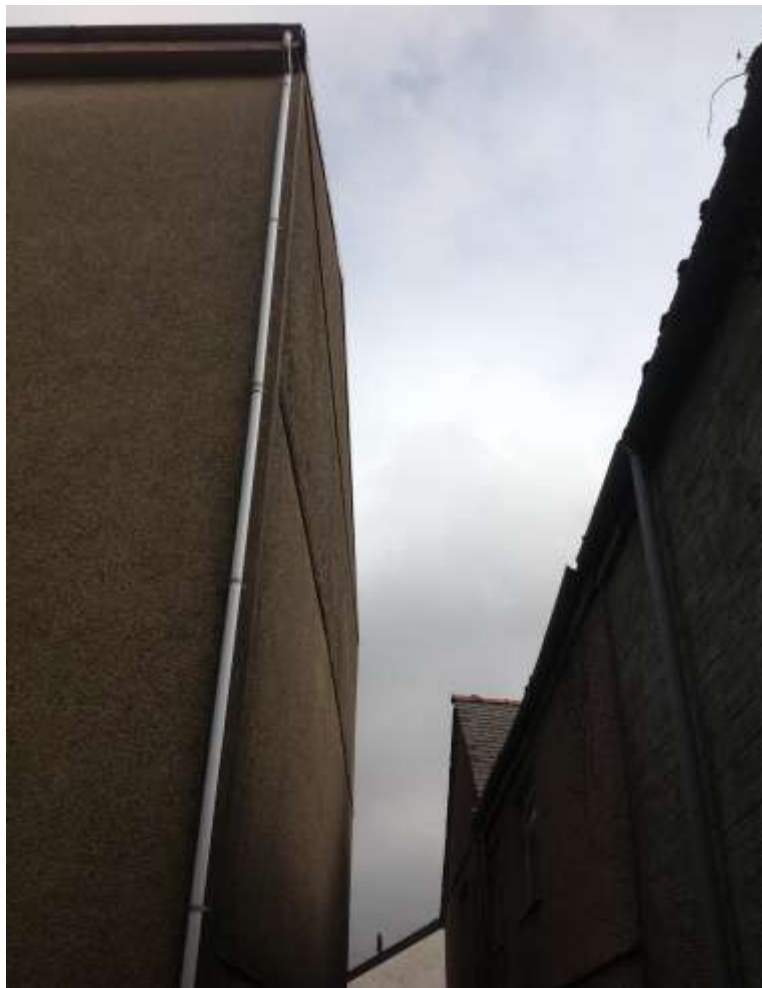
There was some bowing to the main rear wall of the chapel and the rear kitchen wall. The cause is likely to be a lack of lateral restraint. It is noted that the ground floor suspended joists ends have decayed where these are built into the external walls and are not providing any restraint to the rear wall. There also appears to be no lateral restraint provided via the high level ceiling joists. We would advise you to contact a Structural Engineer to advise on this further and any remedial works needed. A photo is shown in the Appendix.

Bowing back wall

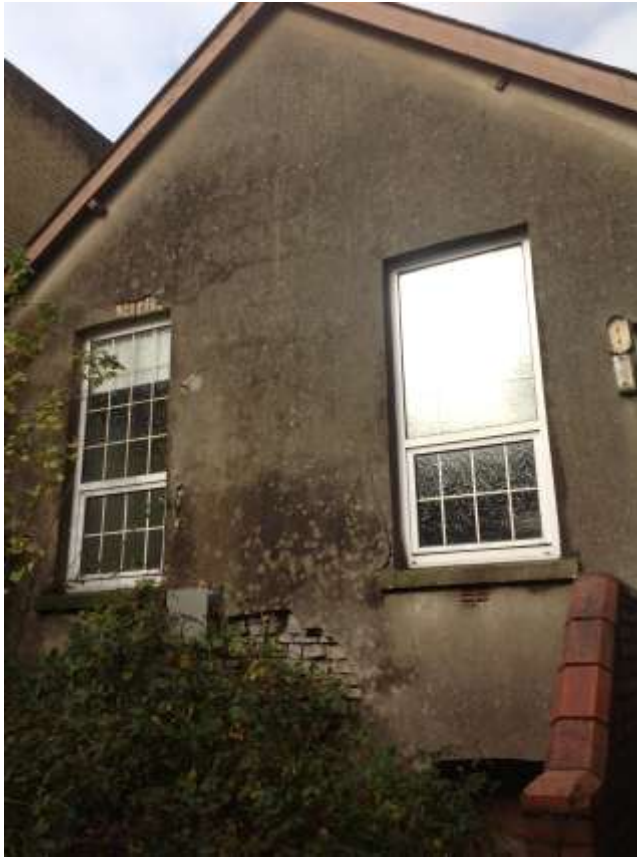
The wall structure behind the kitchen is in poor condition. The complete render to the wall will need hacking off, re-pointing and re-rendering. (see also floor structure). A further inspection is advised once the render has been hacked off from this wall.

Defective render & wall to rear of kitchen. Joist ends have rotted.

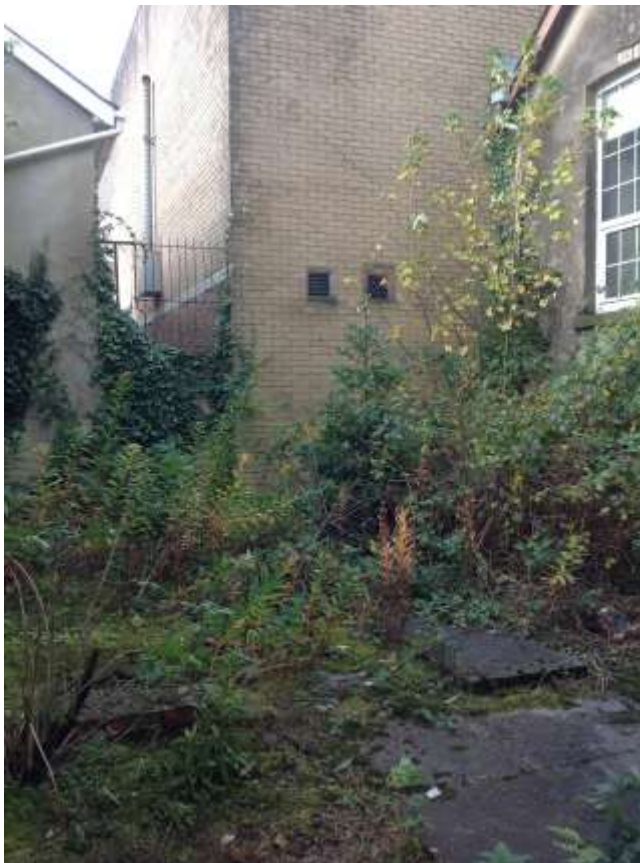
Overgrowth to rear garden

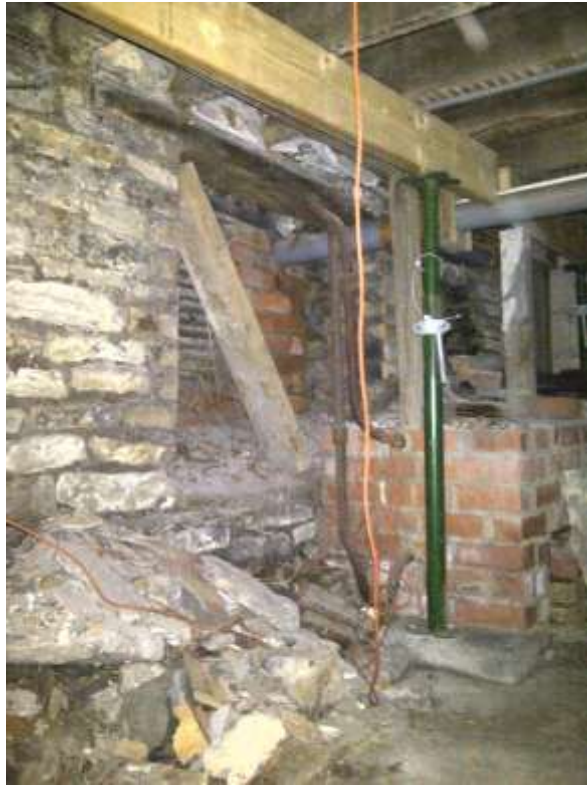
Propping of floor over kitchen

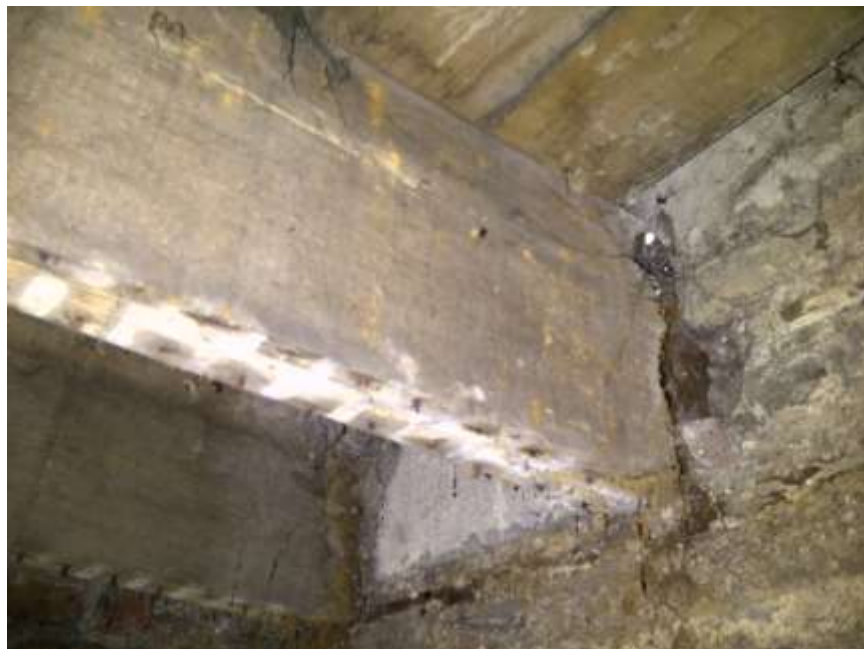
The ground floor suspended floor joists were inspected from the under floor voids. Inspection of the joists on the Southern (rear) end of the property found the ends of the floor joists and timber wall plate have decayed to such an extent where they were built into the external walls that the majority have no support bearing. Temporary support has been provided by acro's and timber beams. We should advise that areas of the floor are in a dangerous condition of collapse. It should also be noted that the decayed floor joists mean that the rear walls do not have laterally restraint.

Decayed timber joist end

Floor boarding needs taking up to allow the joists to be cut back and new sections of treated floor joists installed in accordance with 'TRADA' guidelines/structural engineers recommendations.

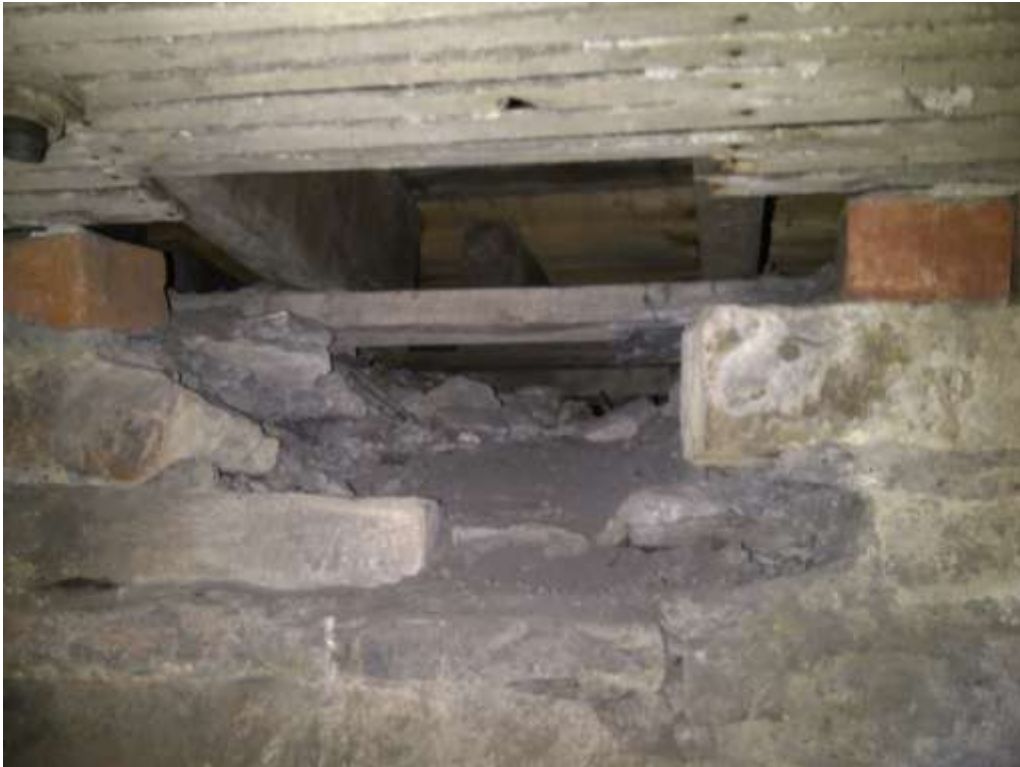
Inspection of the floor joists to the Northern (front) end of the property over the meeting room was not possible as no access to this area was possible however the intermediate stone wall supporting the joists within the sub floor void below the kitchen/meeting room has some voids which need to be filled to ensure support of the joists is maintained. Depending on any rot etc. found under the meeting room it would be worth considering installing a solid ground floor to this area.

Floor void under meeting room.

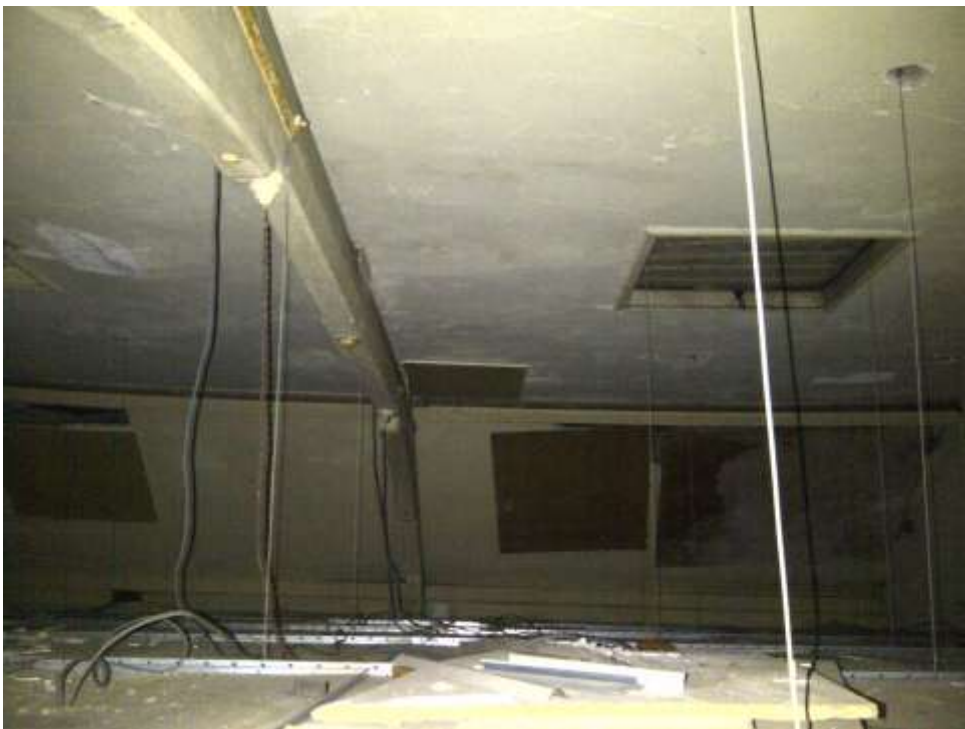
Ceiling area above the suspended ceiling in the meeting room.

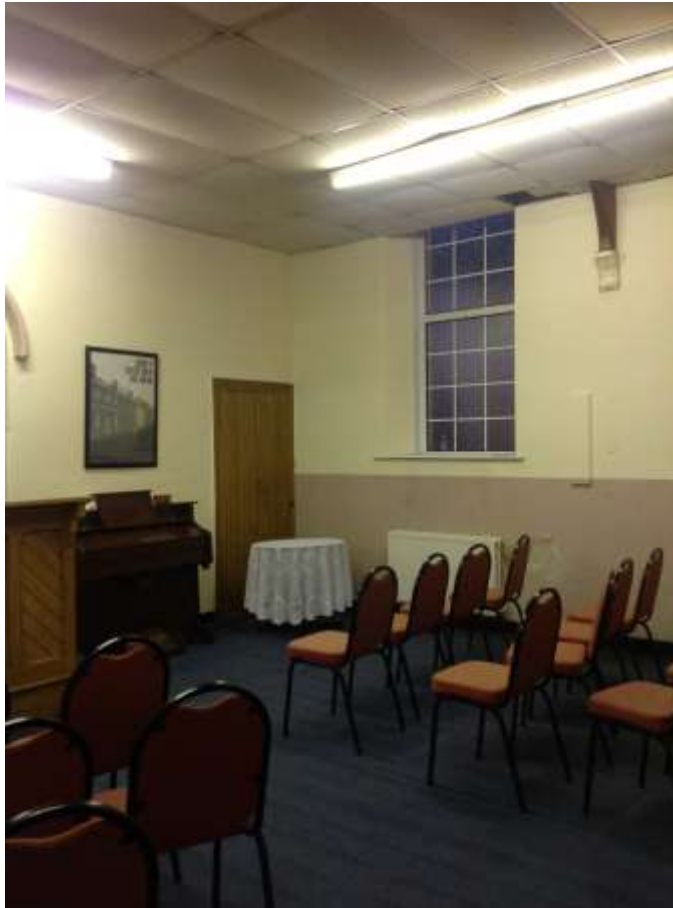
The ceilings in the meeting room and kitchen have suspended ceiling tiles within an aluminium frame. The tiles are aged and bowed and generally in need of replacement. Above the suspended ceiling is the original part splayed part flat ceiling. This appears to be lath and plaster and is in poor condition with cracking and areas where the ceiling has been previously patched with boarding for temporary repairs. You should anticipate having to replace the ceiling finish in the next couple of years. A sample of the ceiling finish will need to be tested for the presence of any asbestos prior to works being carried out.

Suspended ceiling tiles over meeting room.

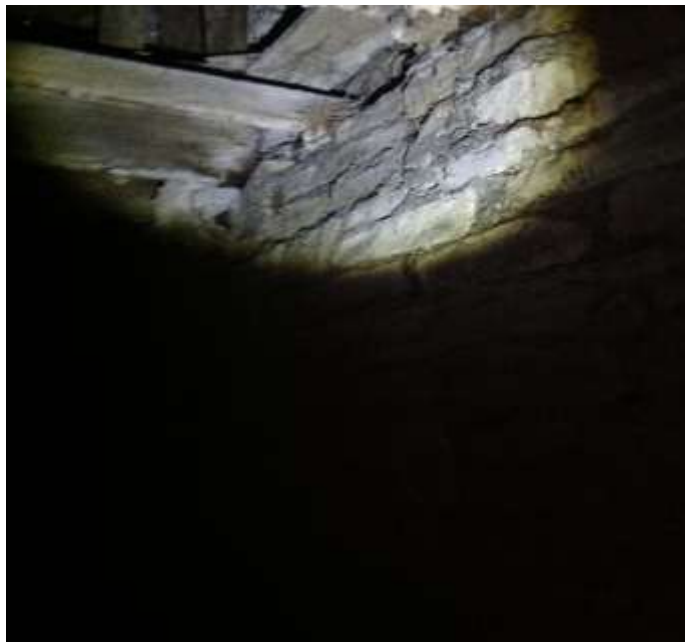
Defective joists over sanctuary (Southern end)

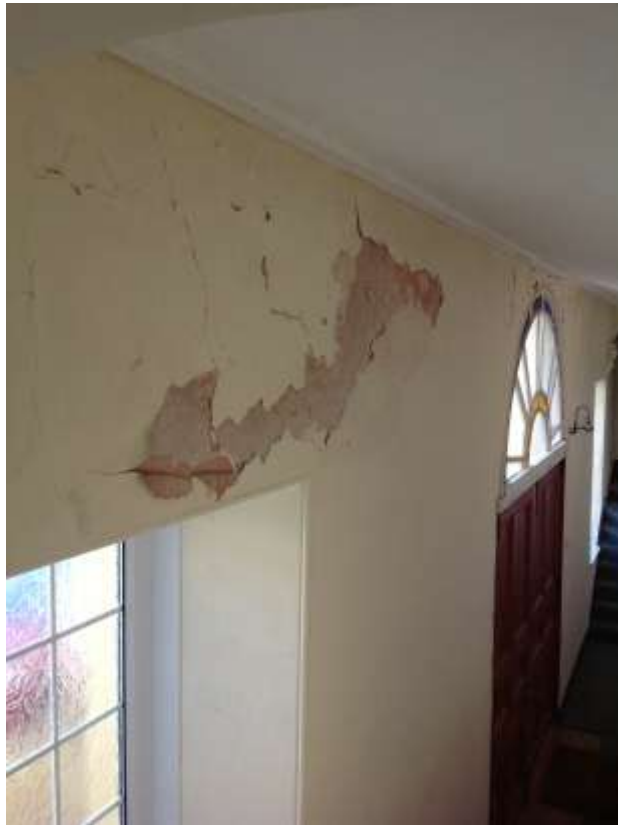
Wall finishes have been extensively effected by penetrating damp and a substantial amount of hacking off and re-rendering / plastering is needed throughout the property.

Internal finishes effected by damp

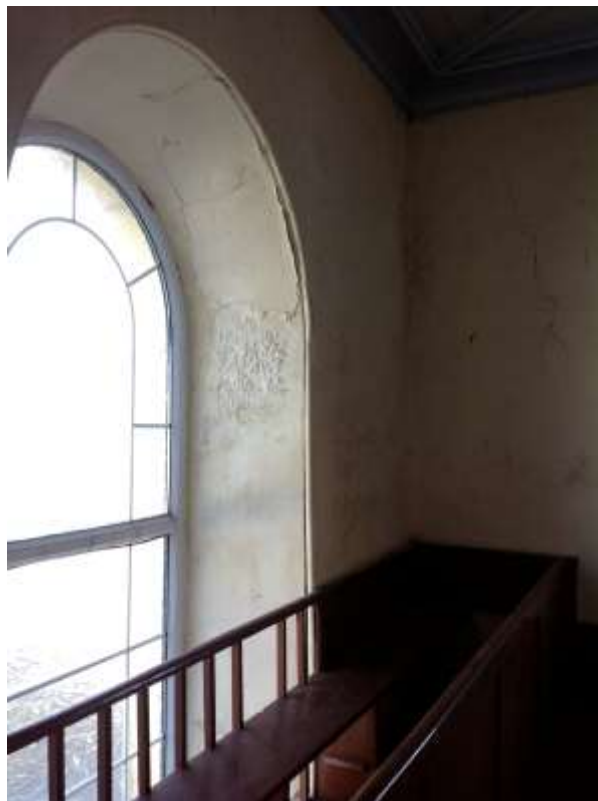
Defective internal finishes to window areas.

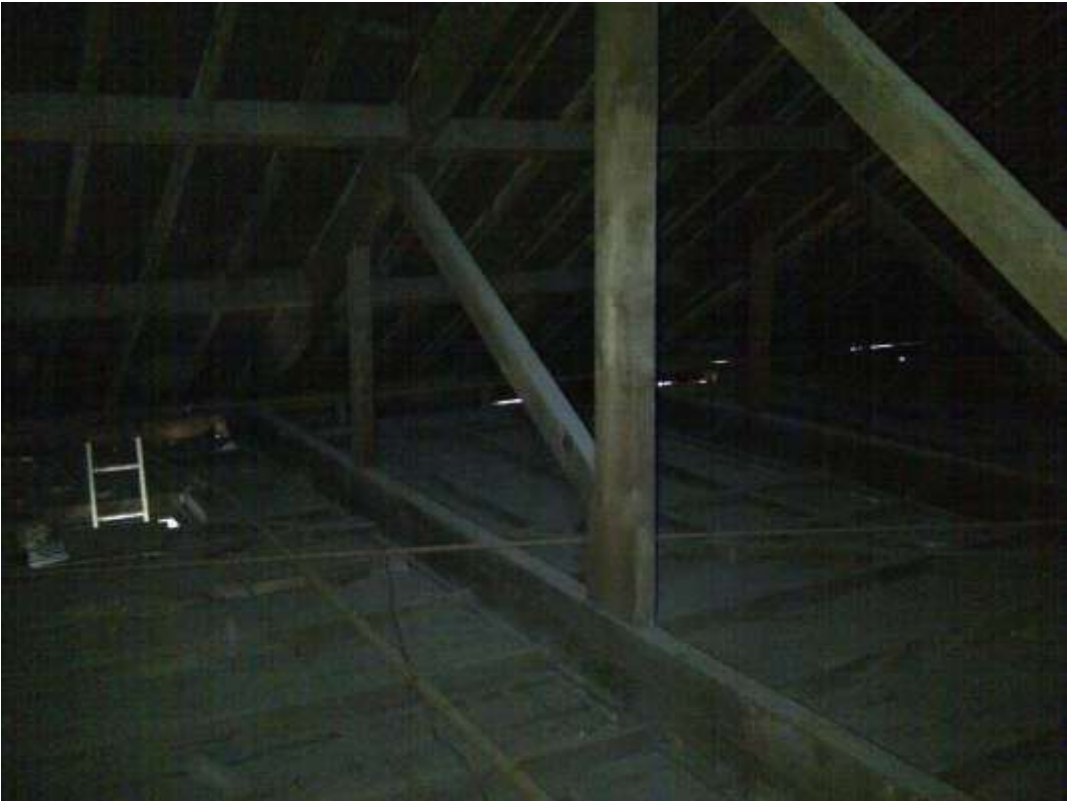
The timbers making up the roof structure were in good order there being no rot / wood decay where seen.

Main chapel roof space

Some debris has been left in the back left corner of the roof void from replacement of the roof finish. This should be removed before it attracts rodents, birds, wasps etc. and also to remove the weight it is placing on the timber ceiling boards.

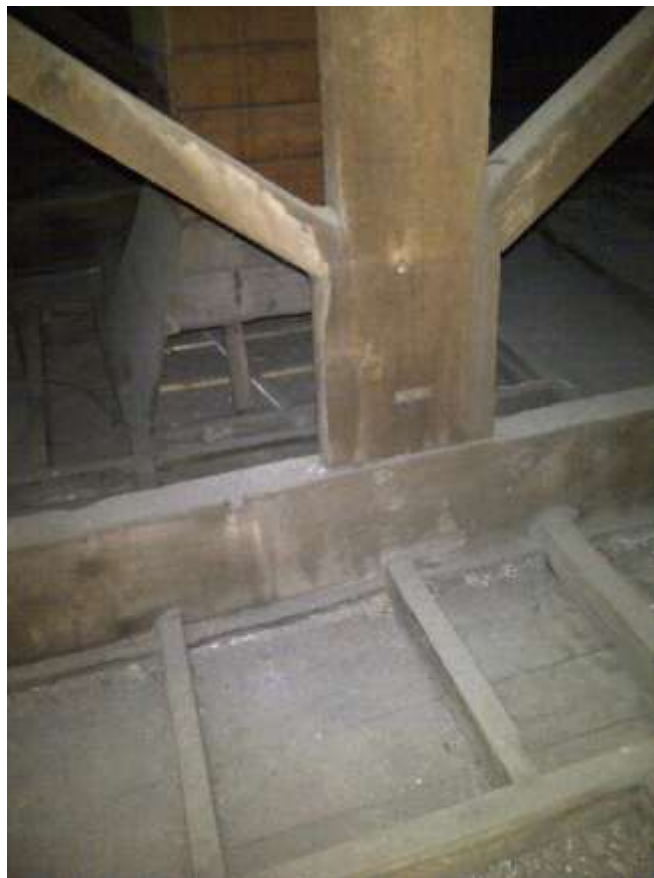
King truss and floor noggins over main chapel
